Service Campaign Bulletin

Campaign No. 2005030005 April 2005
Revised May 2005

SUBJECT: **MODELS 203/210**
PRESERVE DOOR FRAME UNDERNEATH DOOR SEAL

This Service Campaign has been initiated because DCAG has determined that the door frame assembly requires the application of corrosion preservation or it may be subject to premature corrosion.

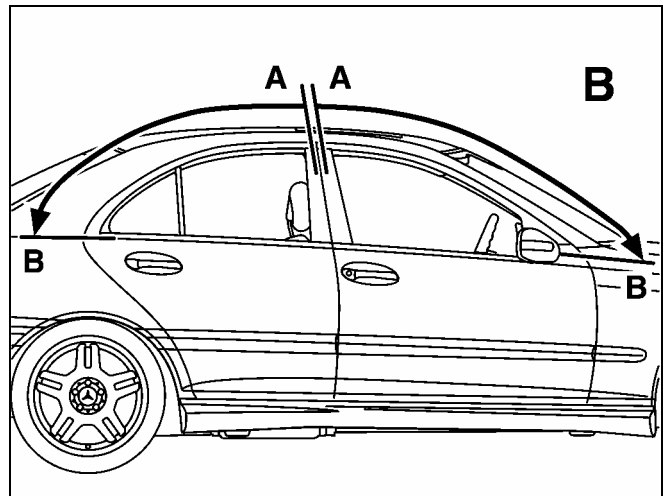
Figure 2

4. Check to see if any corrosion is present on the door frame seal area. If corrosion is present, refer to WIS: GF98.00-U-9200A for proper evaluation and repair procedures before proceeding.

2. Open left front door.
3. Lift rubber seal from door frame in the upper corner area (A, Figure 2).
