# THE 107—THE “PANZERWAGEN”

## A BRIEF BUYERS GUIDE TO THE 350SL, 450SL, 380SL, 560SL, 450SLC, AND 380 SLC

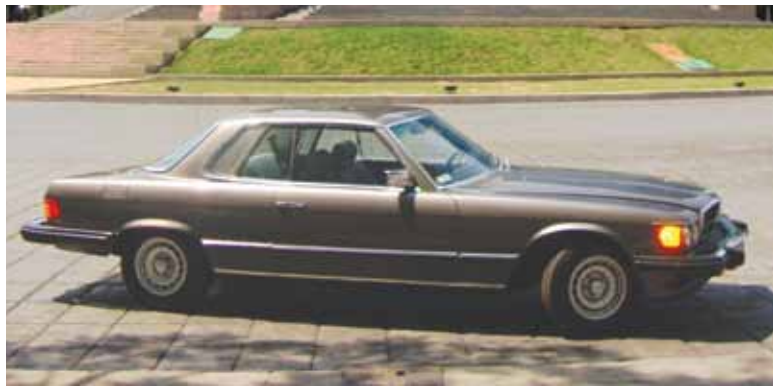
The SLC (C107) was an attractive alternative to the R107 roadster body style. This 1981 450SLC is in exceptional condition, illustrating how careful use and good maintenance can preserve these cars.

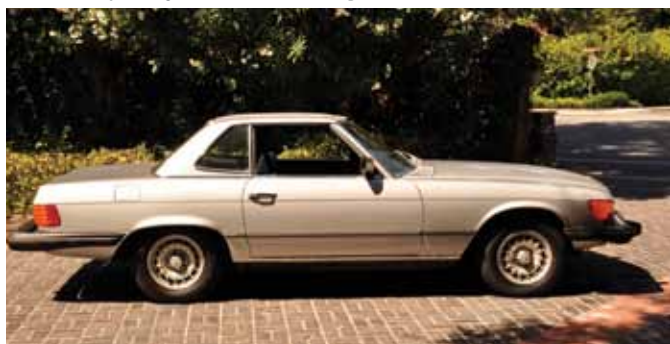
With the hardtop installed (a two-person job, but good garage hoists are available), the SL looks quite stylish, is more weathertight, and feels more solid on the road.

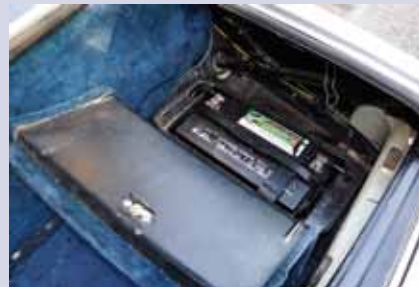
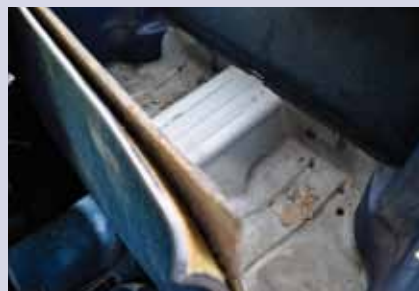
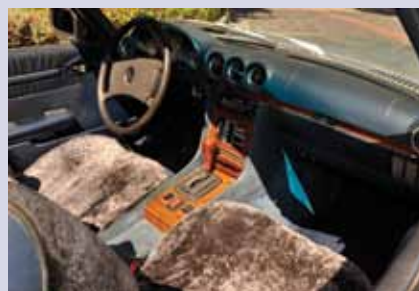
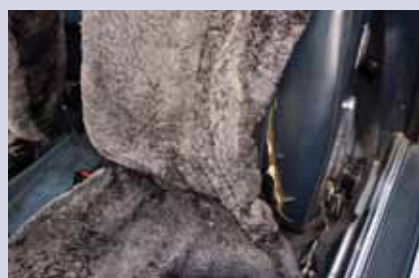
Not surprisingly, the dash cover is cracked, and rubber door seals and fabric draft seals are very worn. Like most SLs of its generation, it has had sheepskin covers since new, and the M-B Tex is in good shape, but the driver's seat has a rip on the outside bolster and the springs and padding are tired.

Our example, a 1978 450SL, has been owned by the same person since 1984, and has accumulated 238,500 miles. A California car since new, it has been garaged all its life and, according to the detailed records kept by the present owner, has received every A, B, and C service at correct intervals. The front subframe was replaced under warranty. The timing chain and belts were replaced in 1990, the top end of the engine was serviced in 1994, it was repainted and the windshield replaced in 1995, and the top was replaced in 1996. It has just passed California smog inspection. Family circumstances motivate the sale.
